March 4, 2016

RE: Weekly Project Status Update Report, Wrangell Junkyard Site Cleanup

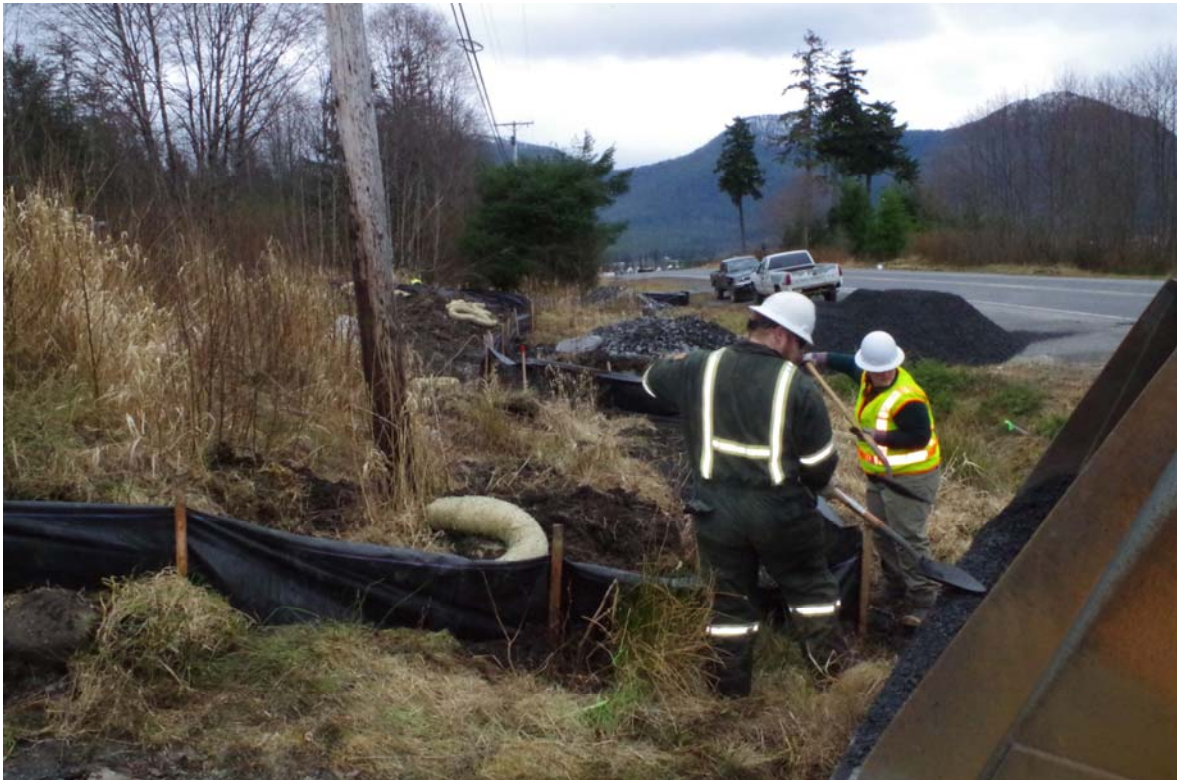
Photo 1: *Installing silt fence at lower portion of Project Area in accordance with SWPPP*

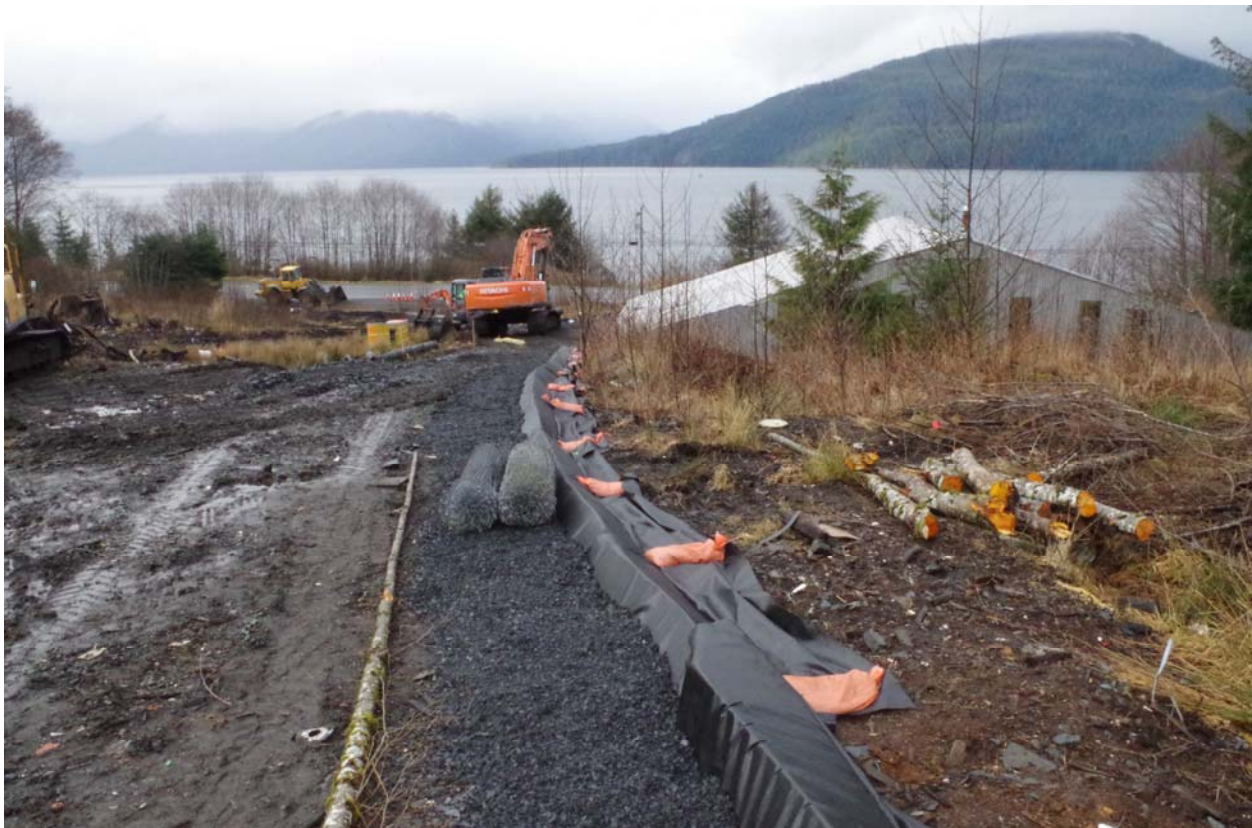
Photo 2: *Installing silt dike along Project property boundary above Byford residence*

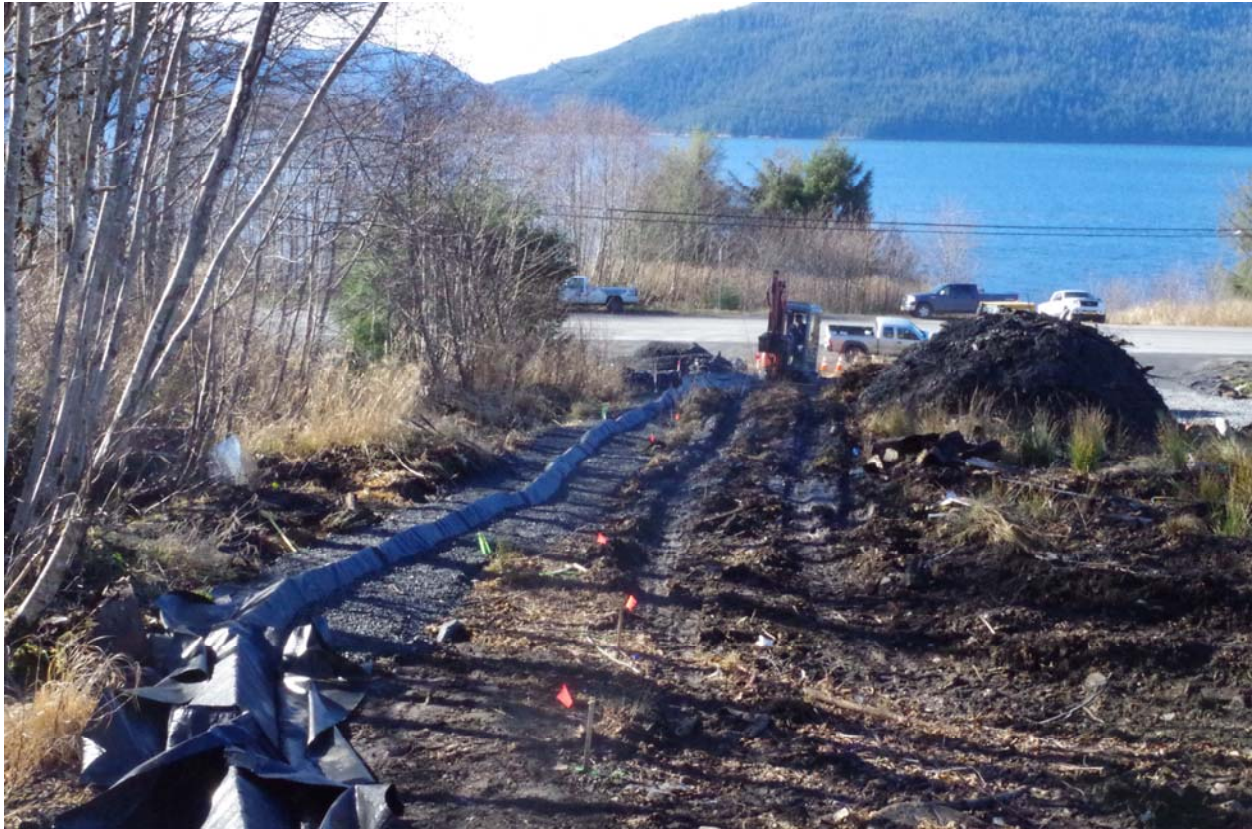
Photo 3: *Installing silt dike along southern edge of project area*

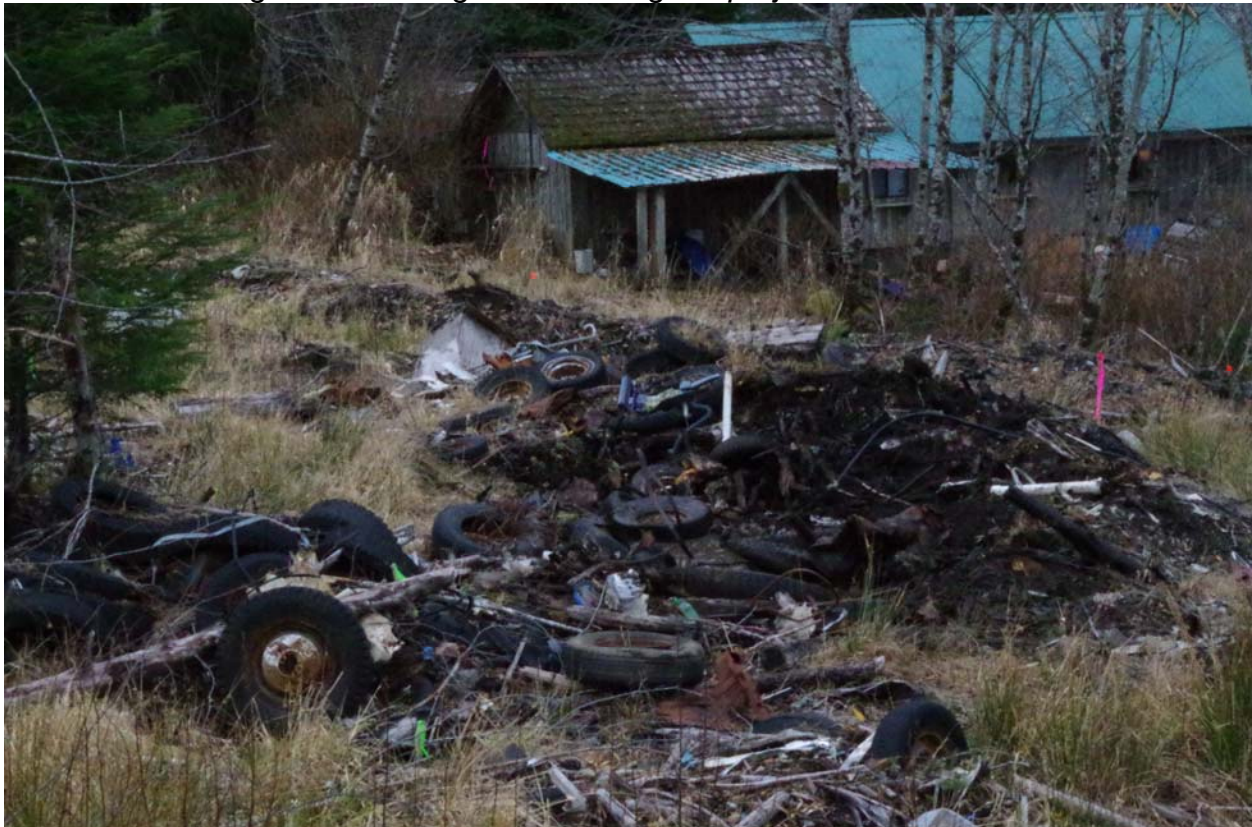
Photo 4: *Project area surface debris*

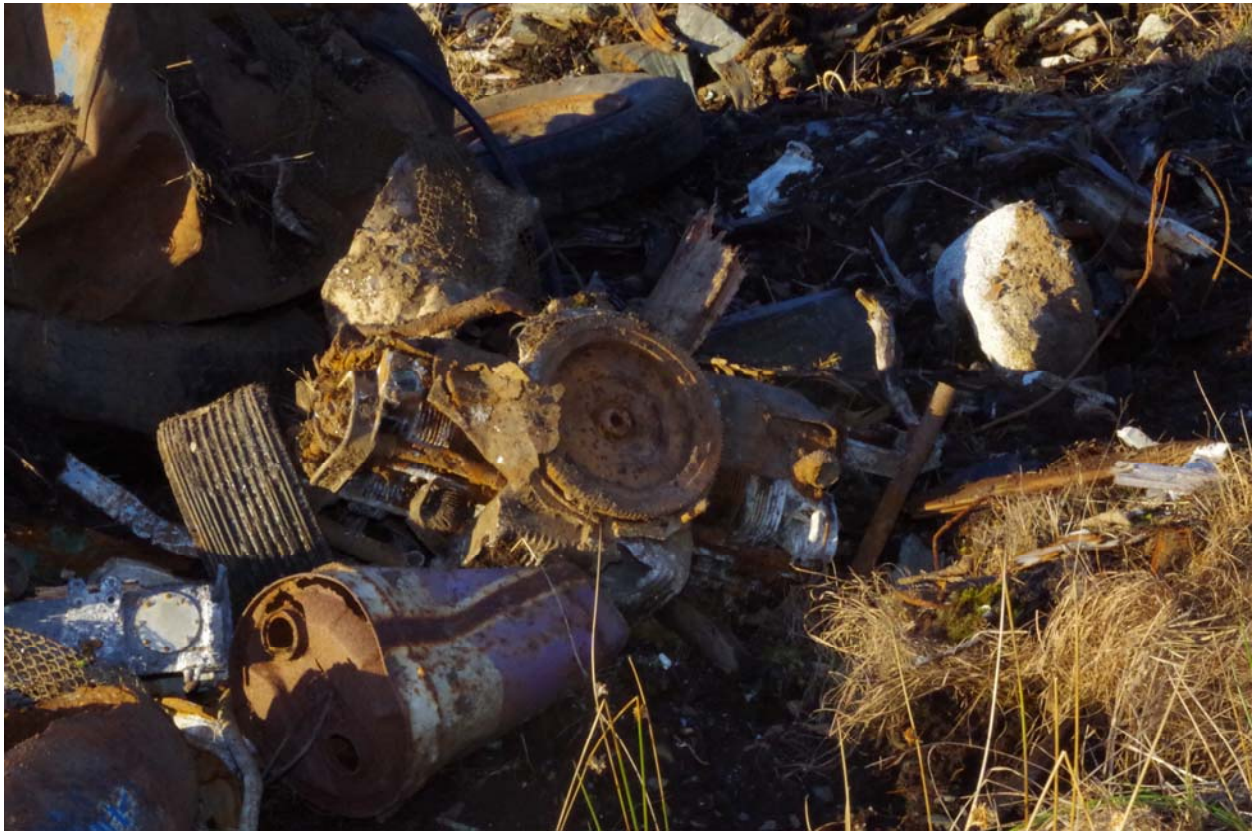
Photo 5: *Project area surface debris*

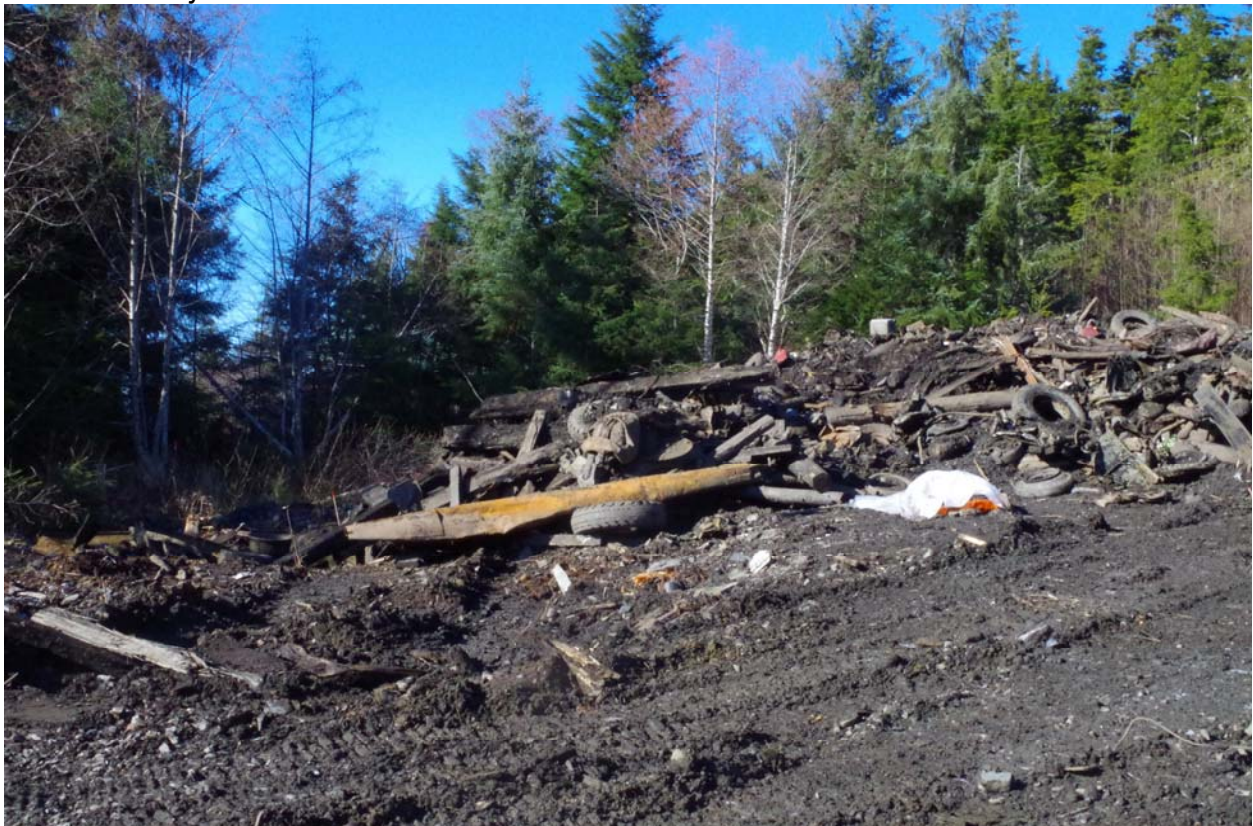
- Roughly 650-700 cubic yards of surface and excavation area debris has been removed and stockpiled so far
- Debris encountered has included buried chain link fencing; tires; batteries, both intact and broken; automotive engines and body pieces; stacks of automotive rims welded together; piping; cables; and two compressed gas cylinders, one empty and one full. The full cylinder contained nitrogen gas and was vented on site.

Photo 6: *Project area debris stockpile*

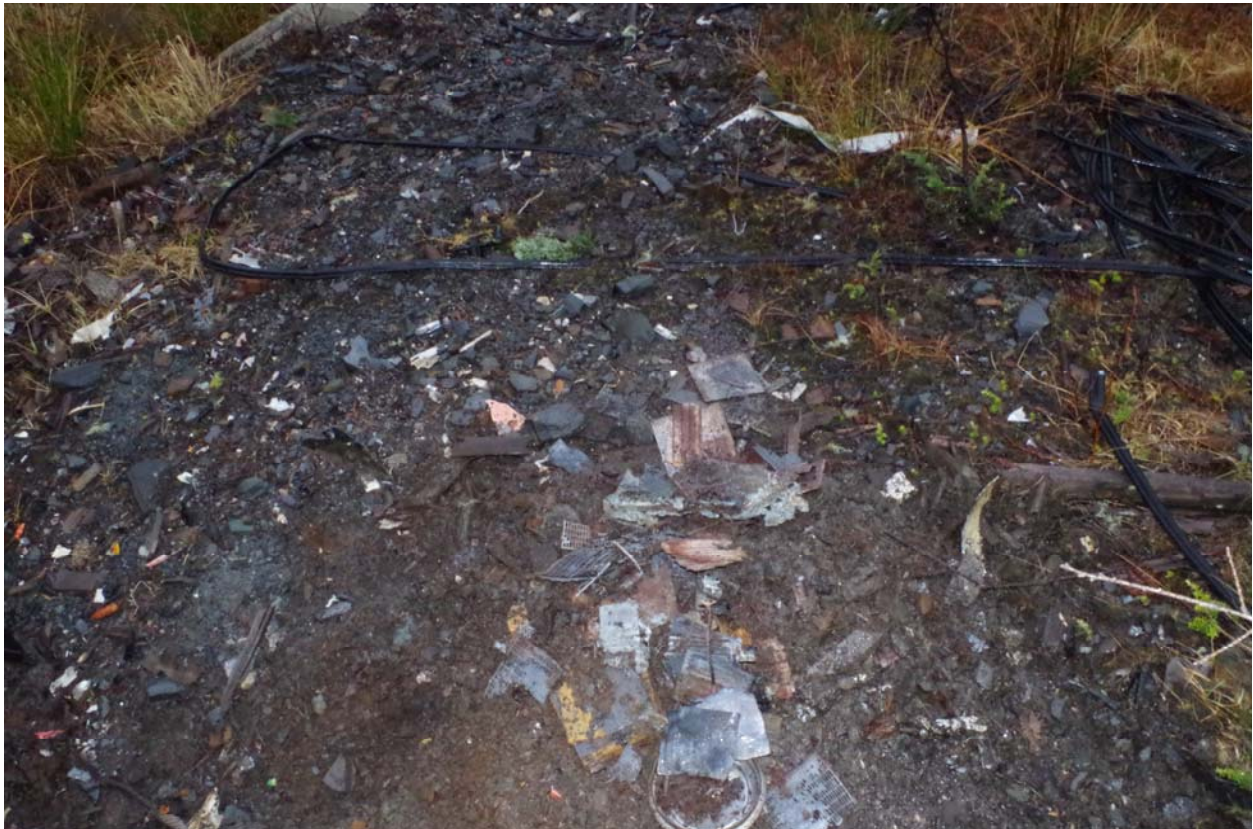
Photo 7: Broken batteries and lead plates located on surface within Project Area

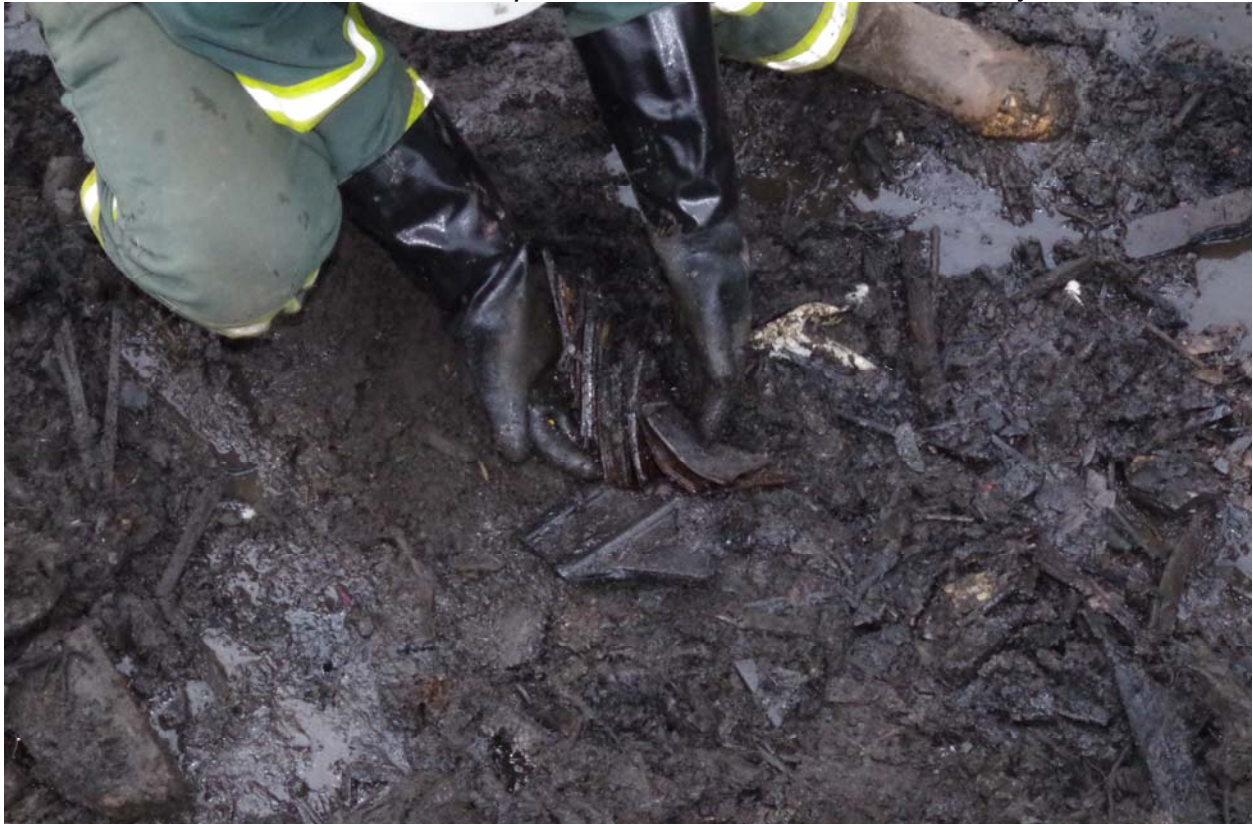
Photo 8: NRC personnel hand removing lead plates and battery surface debris

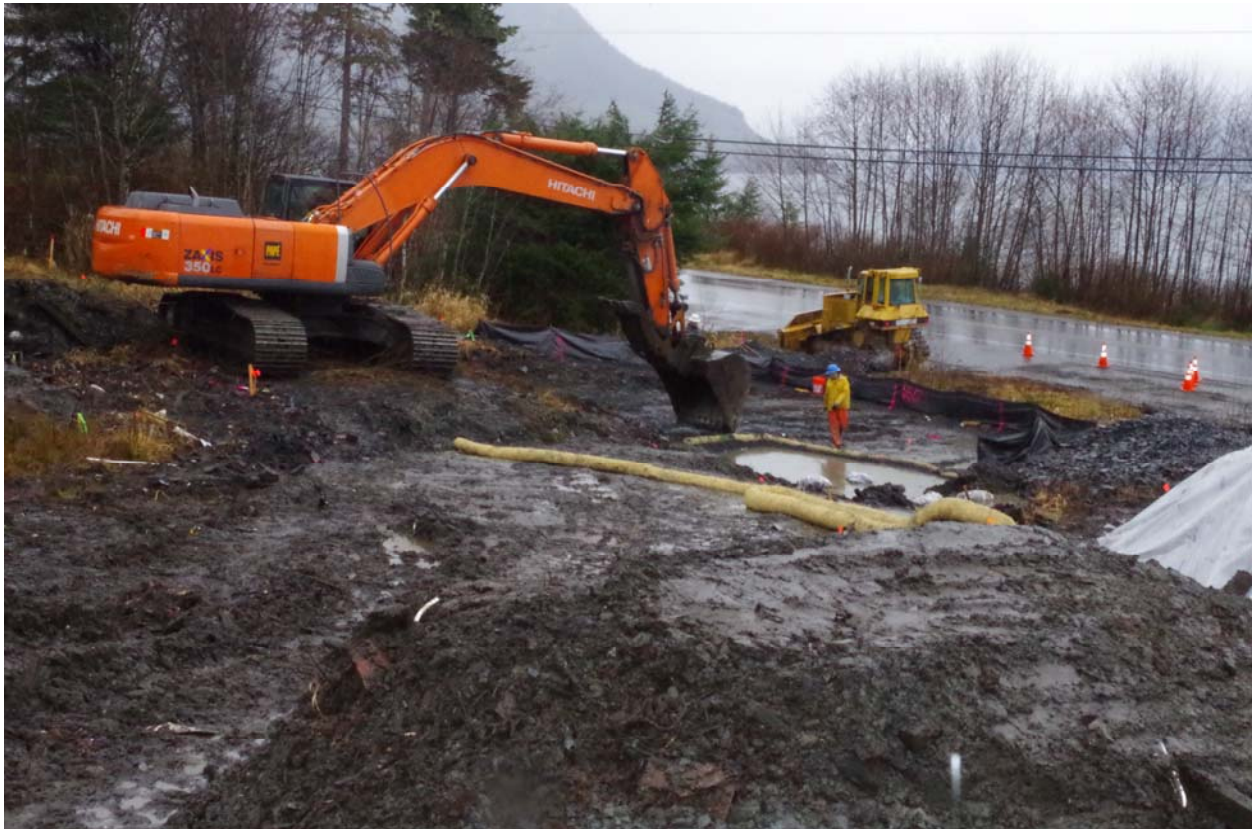
Photo 9: Beginning excavation of contaminated material at lower end of project area

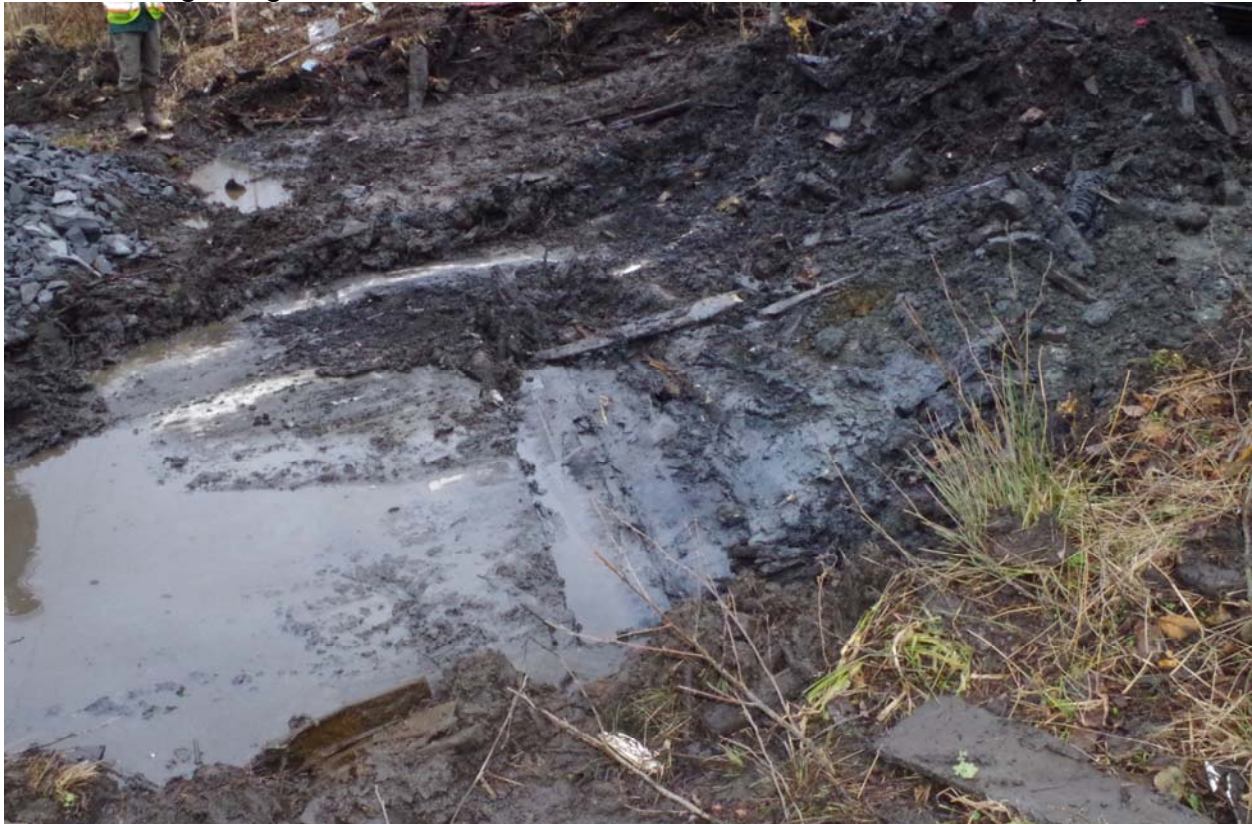
- At the lower end of Area A, four concrete pads were found, each separated by about an 18 inch gap.
 - Within the gaps were located steel piping with drainage slits cut into them. The pipes were filled with petroleum contaminated fines, and the soils in this area were visually petroleum contaminated.

Photo 10: Concrete slabs, with POL contaminants between slabs. Lower portion of project area

- This material has been stockpiled separately and covered while we await laboratory data.
 - Roughly 120-150 cubic yards of petroleum contaminated material is stockpiled separately

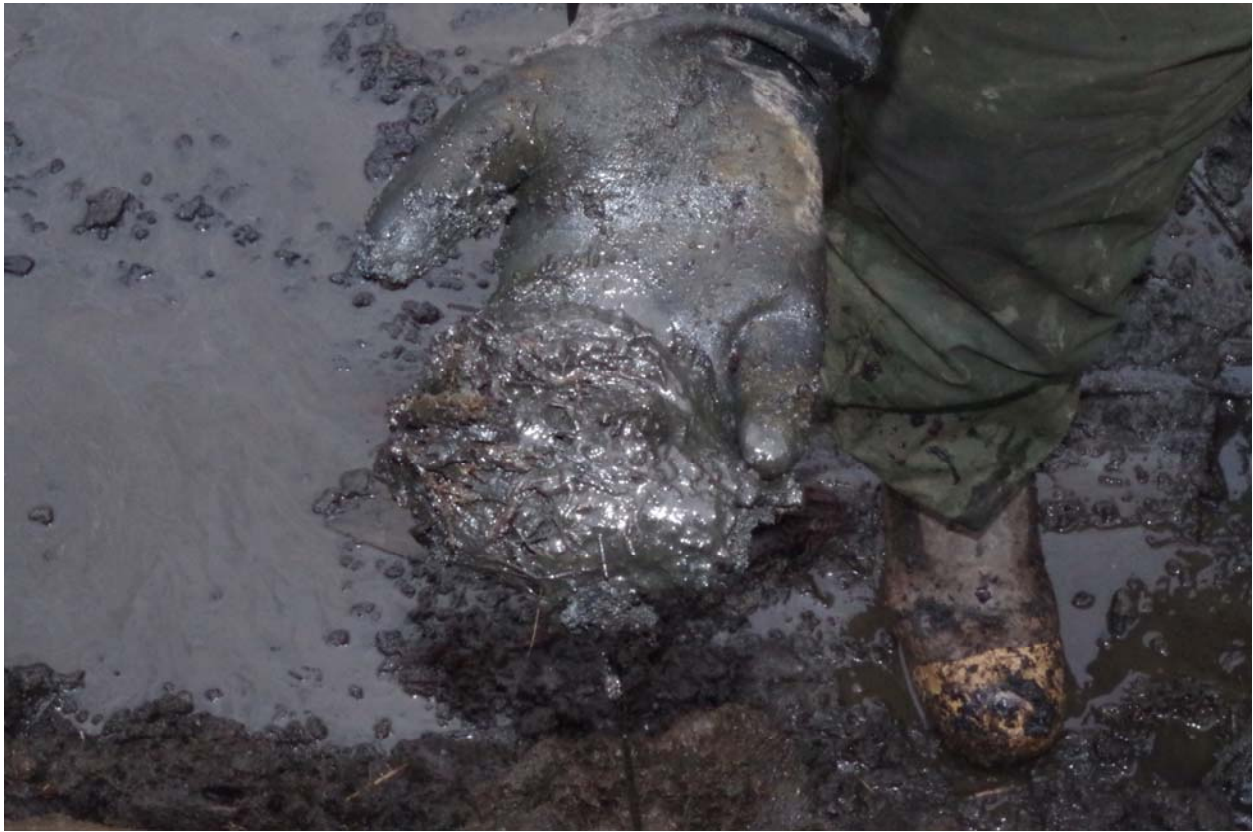
Photo 11: *POL contaminated material located lower project area.*

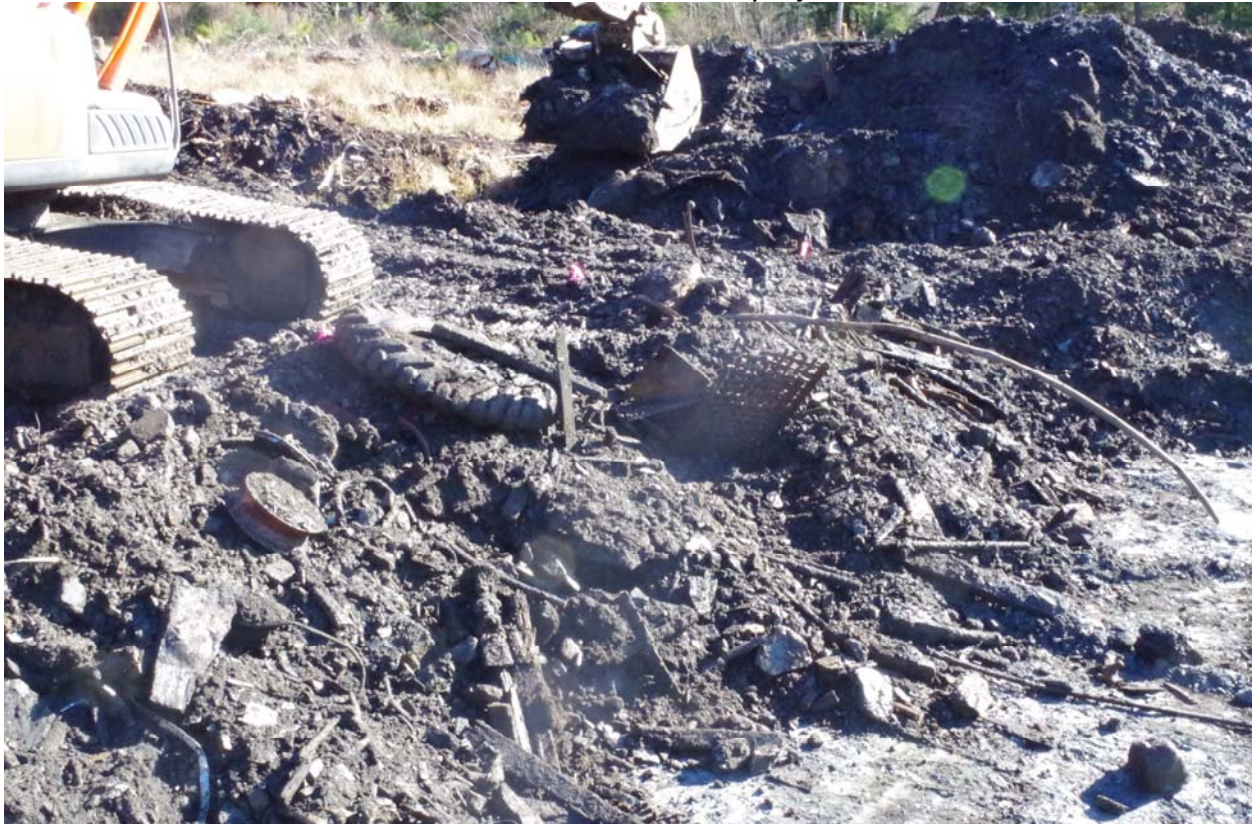
- The lead contaminated soils are deeper into the site soils than anticipated.
- NITON XRF readings are consistently above the established screening levels within the soils above the blue clay layer.

- Brown muddy debris laden soil readings range from 56 – 1004 ppm lead on the NITON
 - Blue clay layer readings have ranged from 8 -38 ppm lead on the NITON

Photo 12: *Excavating lead contaminated material from lower project area, note amount of debris present.*

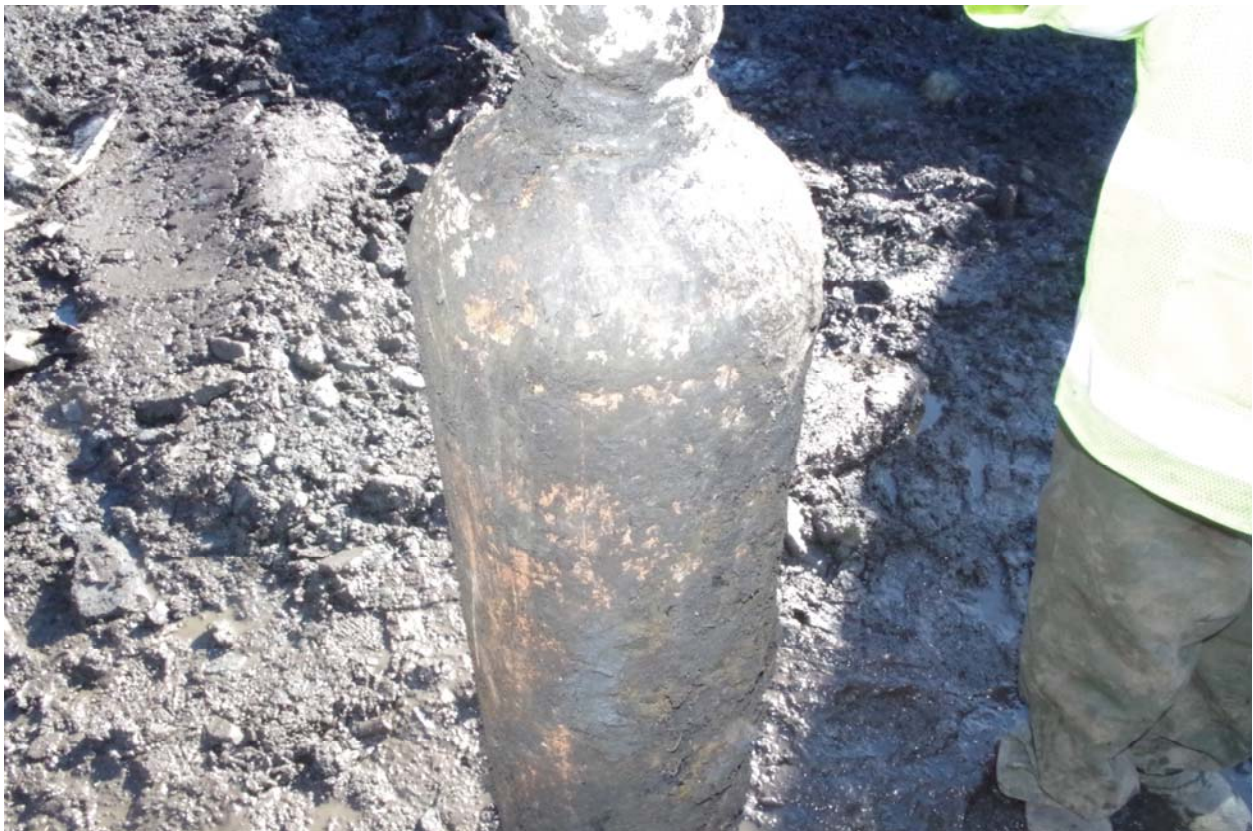
Photo 13: *Intact compressed gas cylinder found buried amongst debris while removing contaminated materials*

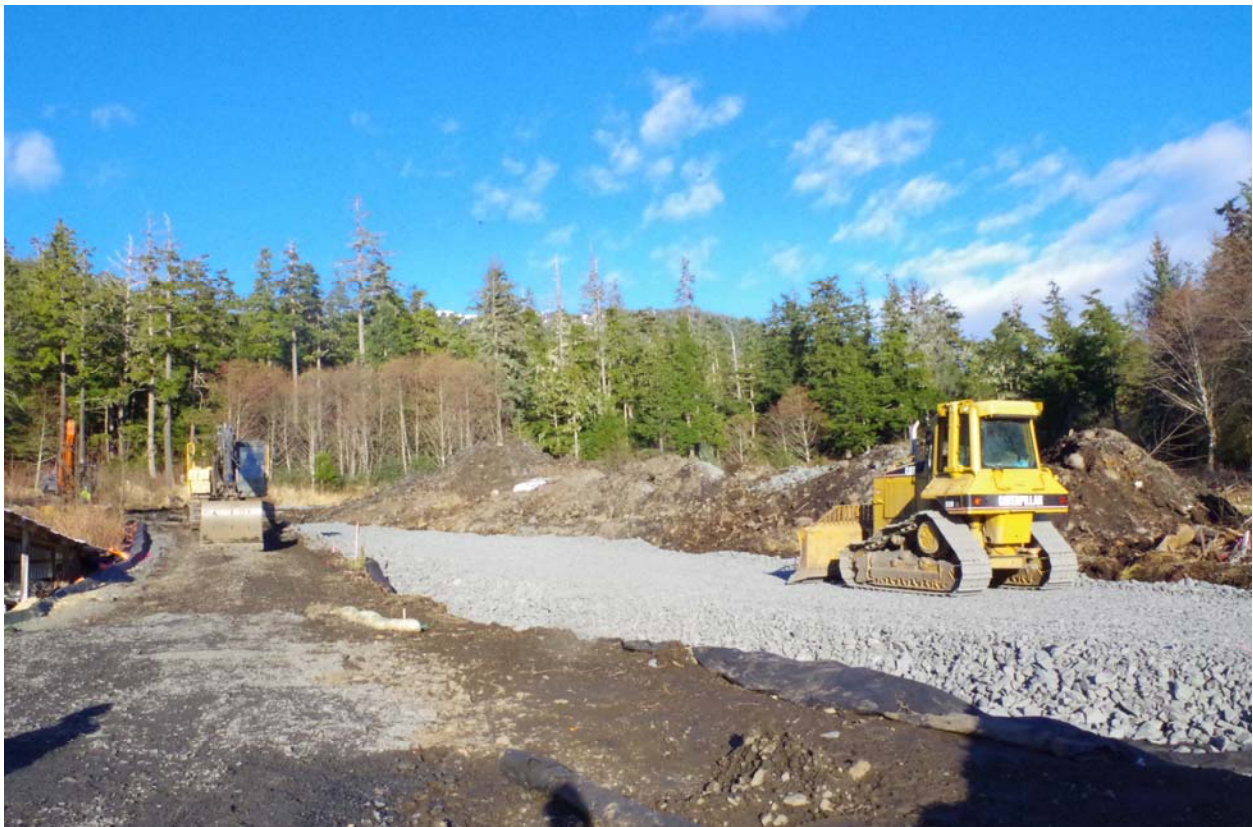
Photo 14: *Access road constructed over clean material within project area.*

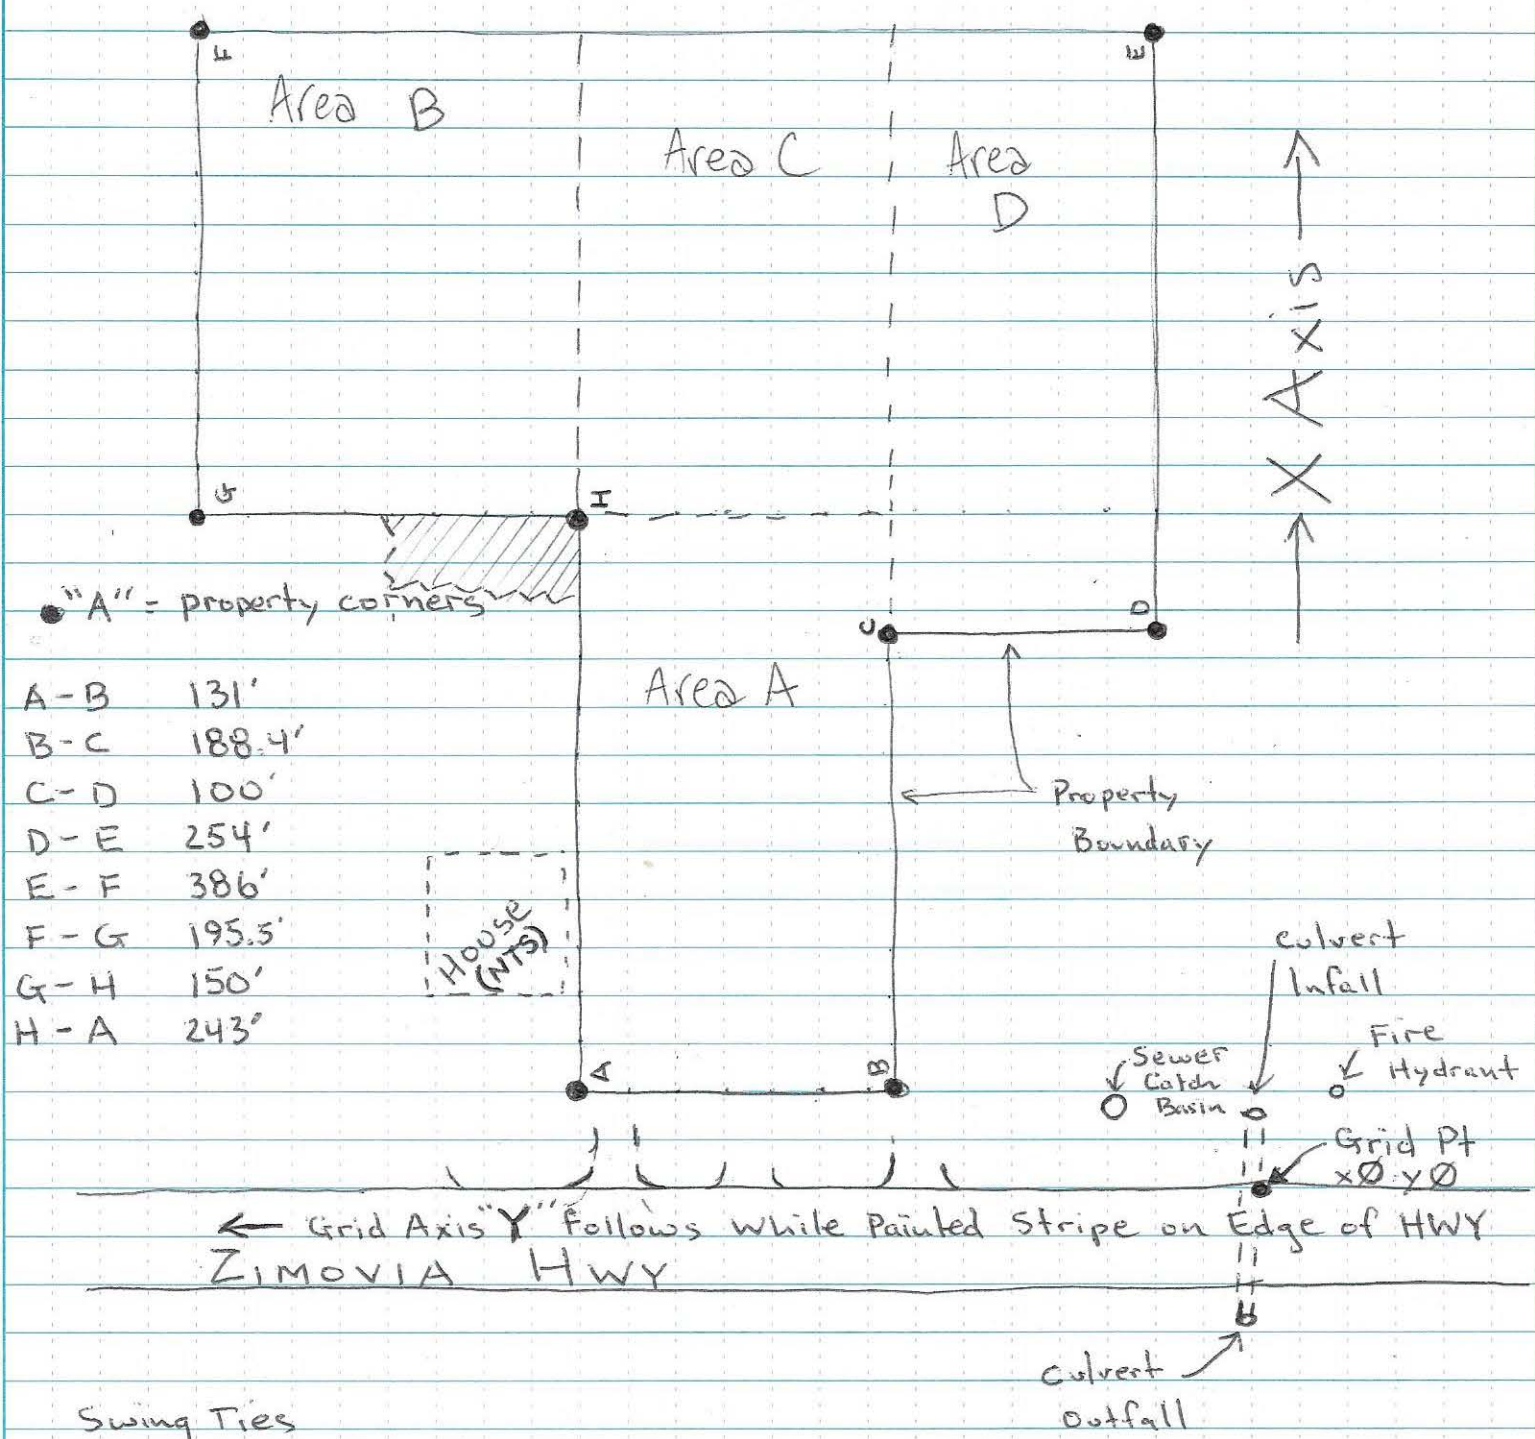
Limits of
Excavation &
field screened
areas as of
March 3, 2016

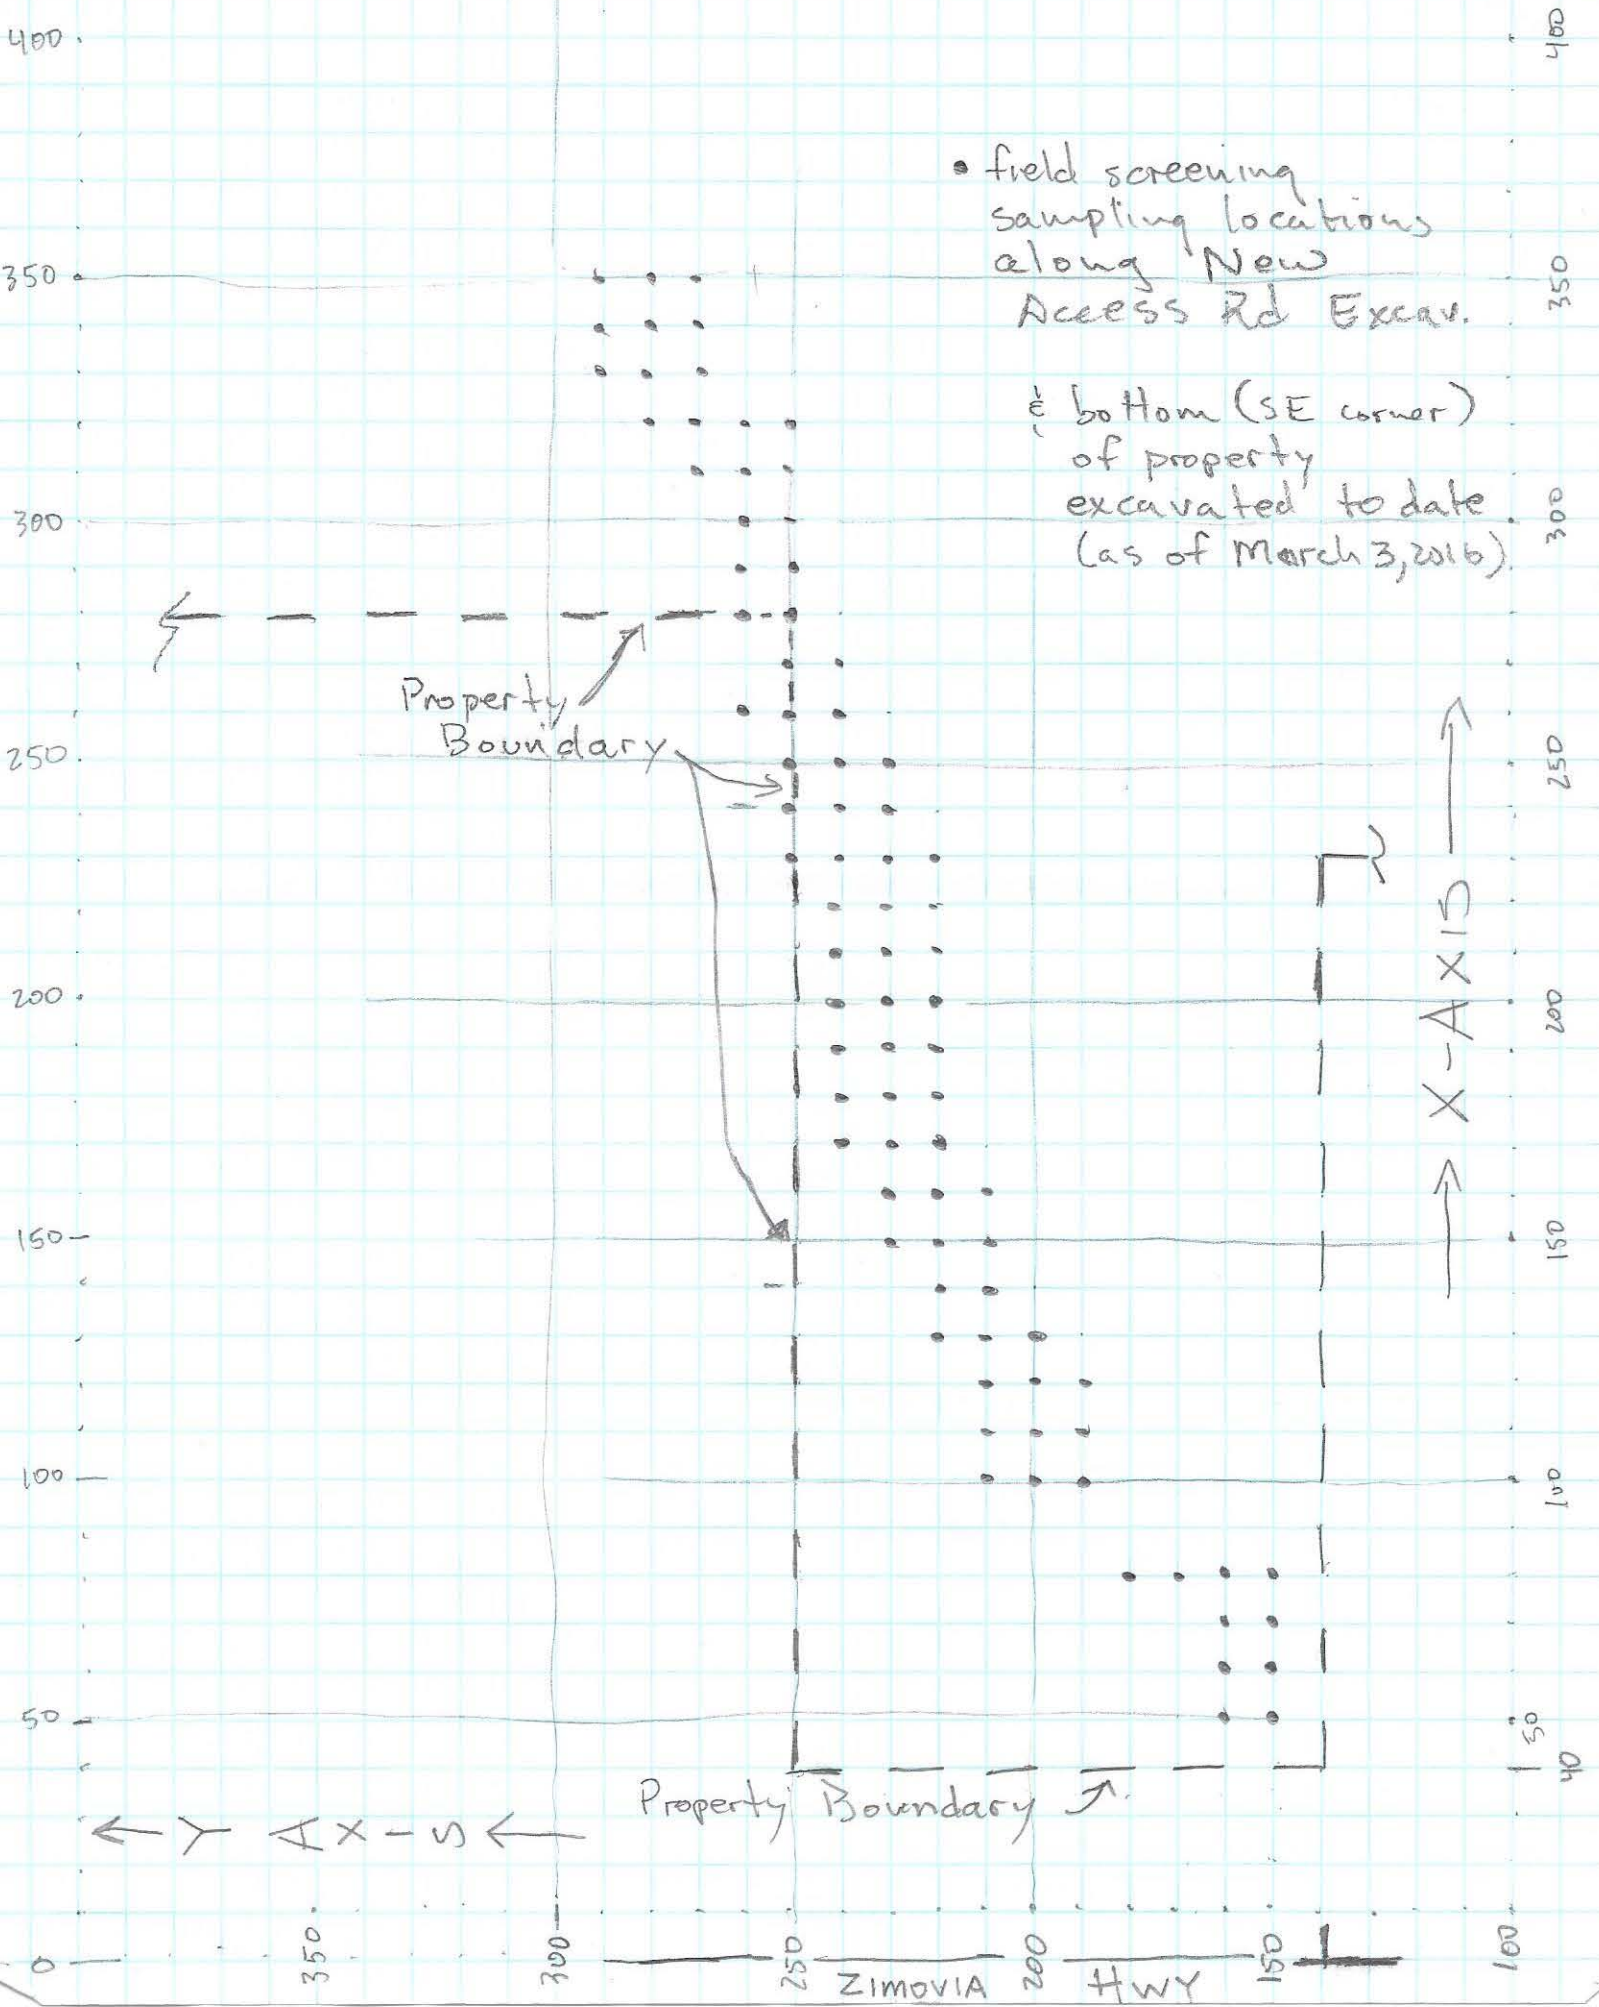
• field screening
sampling locations
along New
Access Rd Excav.

• bottom (SE corner)
of property
excavated to date
(as of March 3, 2016)
